DDASaccident531

DDAS Accident Report

INVESTIGATION REPORT INTO MINE ACCIDENT

WHICH OCCURRED ON 04th MARCH 2004 AT M4101 MINEFIELD, O'Chrey Village, Kamreing Commune, Kamreing District, Battambang PROVINCE

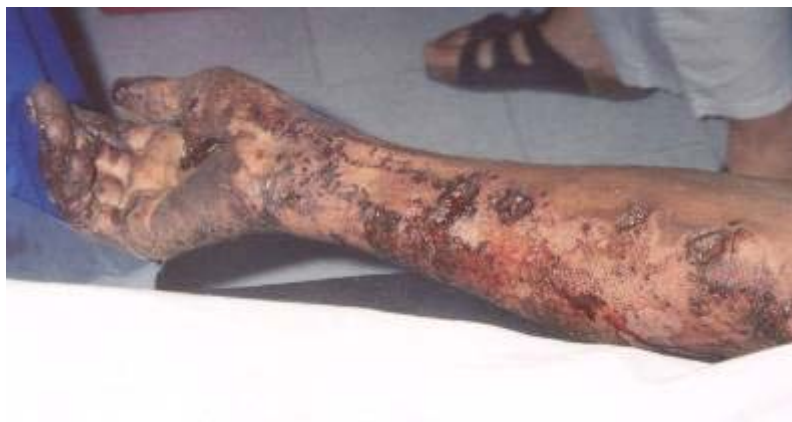
The Victim deliberately walked outside the marked area, using a path that he and others frequently used. The line of previously discovered mines was close to, but inside, the perimeter tape. Clearly the hazardous area had not been marked appropriately during survey. That is not unusual because accurate survey is very difficult, but it is why the primary cause of this accident must be listed as “Inadequate survey”.

The secondary cause is listed as a “Field control inadequacy” because the extent of the hazardous area had not been appropriately adjusted after a mine line had been found. Generally, a distance of at least five metres (normally ten) on both sides of a mine-line will be cleared. This is intended to catch “strays” that may have been moved by weather or may have been used to “patch” the original mine-line after mines have detonated. If this had been done, the mine just outside the perimeter tape would have been found during clearance.
